## Top tip: Taranis navigation button repair

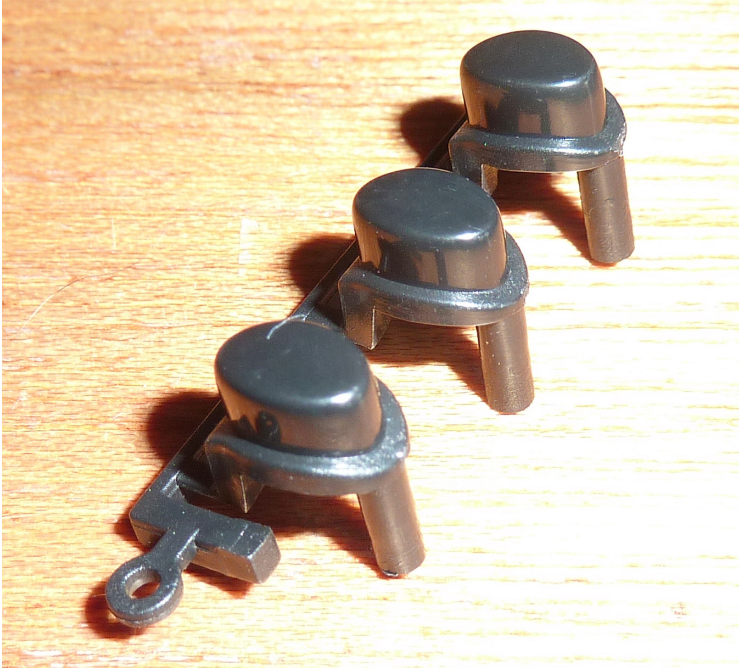
After three years of intensive use I have only come across one design weakness in the Taranis X9D. My + navigation button started to work intermittently then stopped altogether. I dismantled the transmitter and discovered that the three buttons are on a plastic strip that glues onto two pins. The underside of each button is a plastic spike that pushes a microswitch on the main circuit board as you can see on the picture below.

I reconnected the battery, switched on and, taking care not to short anything, I tested the relevant switch. It worked fine, so obviously the spike had worn. I had already bought a replacement button strip but removing the old one one looked tricky. So I put a dab of thick CA glue on the end of the spike with some accelerator. When it had hardened I pushed the board into place. The spike was now too long so I shaved slices off it with a scalpel until the switch worked again. I don't know how long it will last but it is still working months later.
